ALBA vacuum system installation and commissioning

Lluís Miralles

On behalf of the vacuum Section at CELLS Engineering
Division

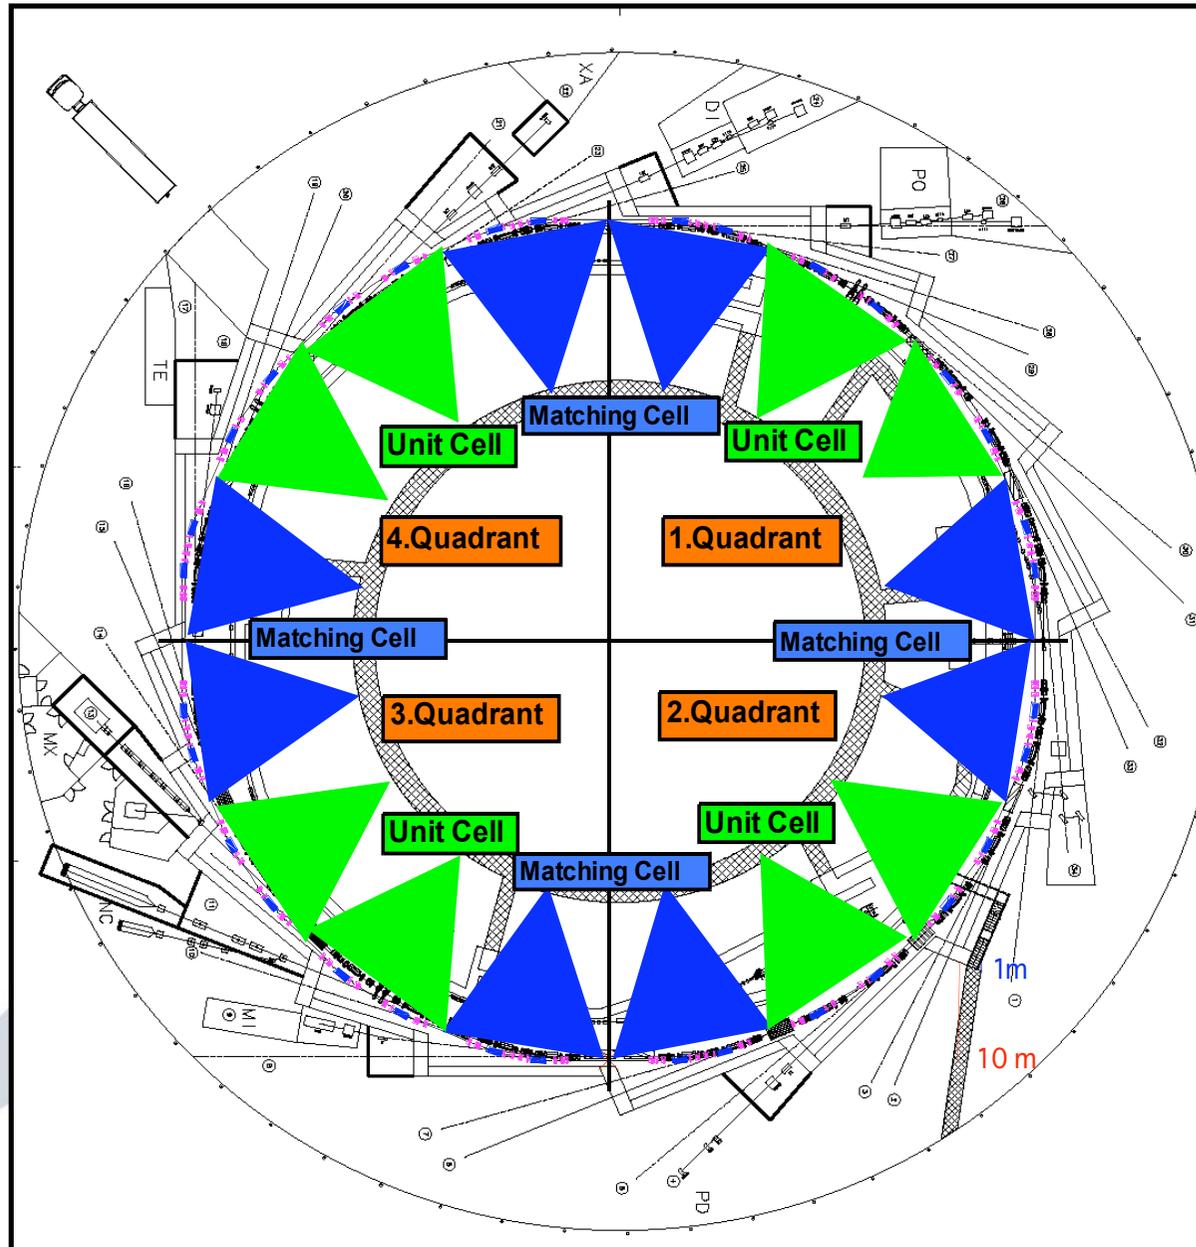
16 cells: 8 unit cells and 8 matching cells.

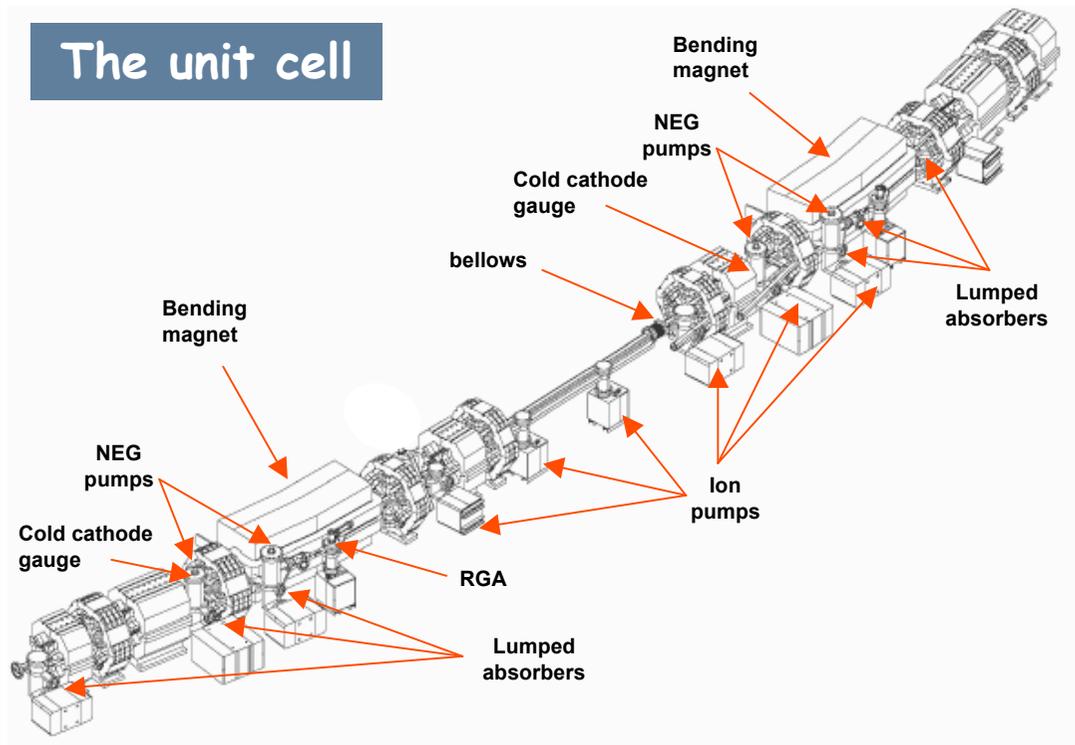
The unit cell

16 cells: 8 unit cells (length=13 m) and 8 matching cells (length=11 m)

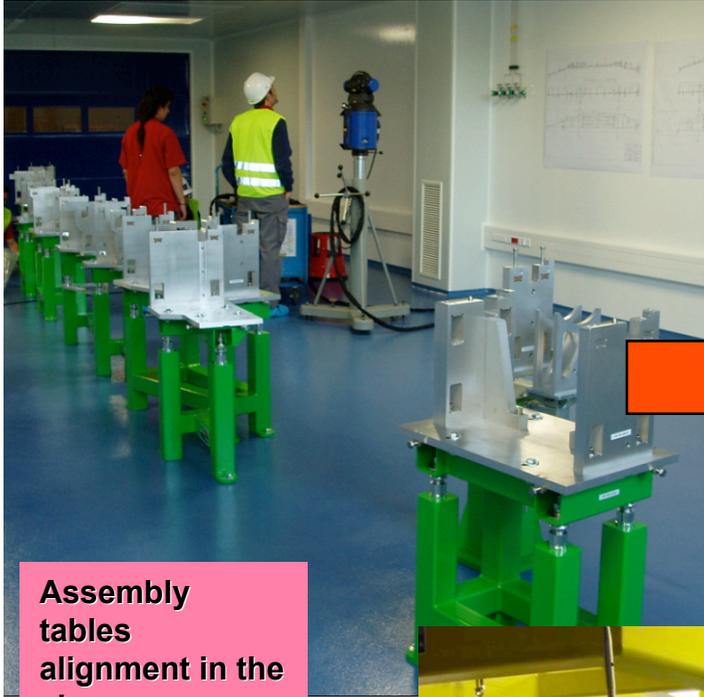
Assembly tables alignment in the clean room

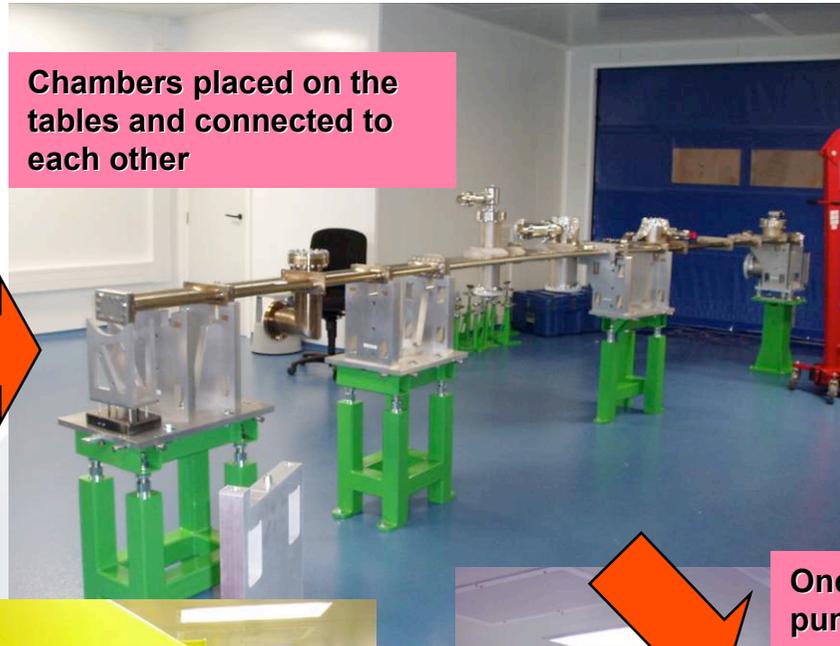
Chambers placed on the tables and connected to each other

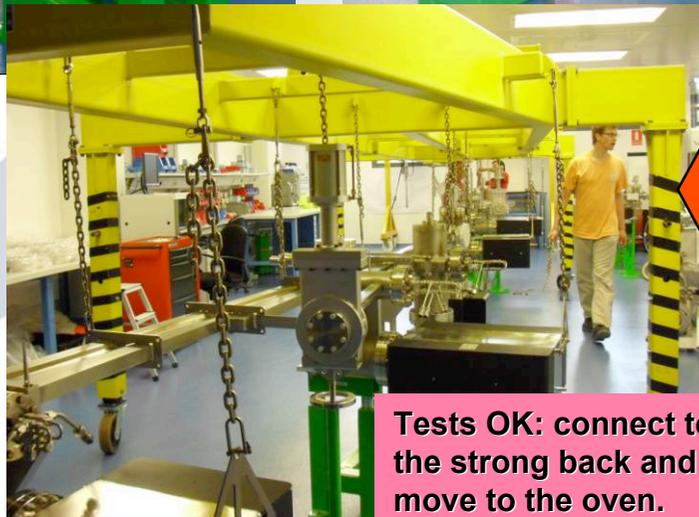
Tests OK: connect to the strong back and move to the oven.

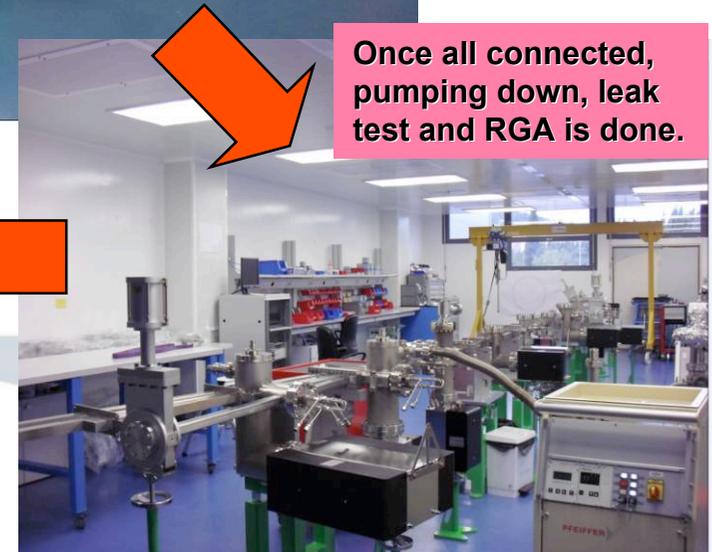
Once all connected, pumping down, leak test and RGA is done.

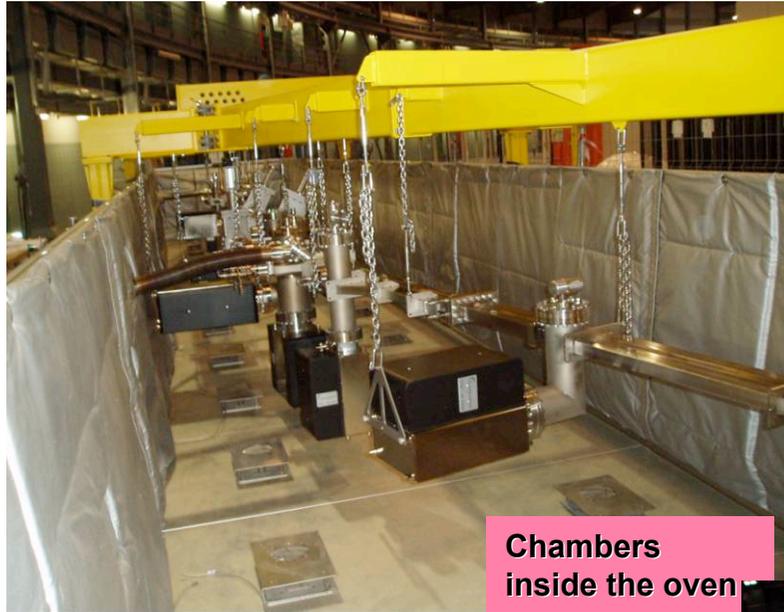
Chambers inside the oven

Pumping down, leak test and RGA scan

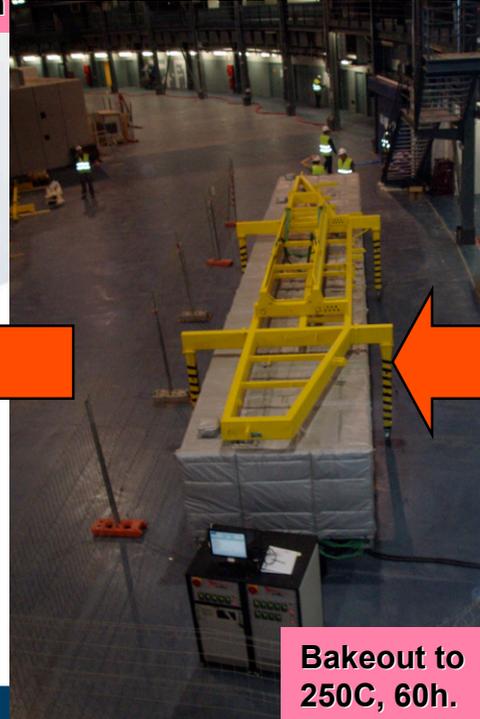
Bakeout to 250C, 60h.

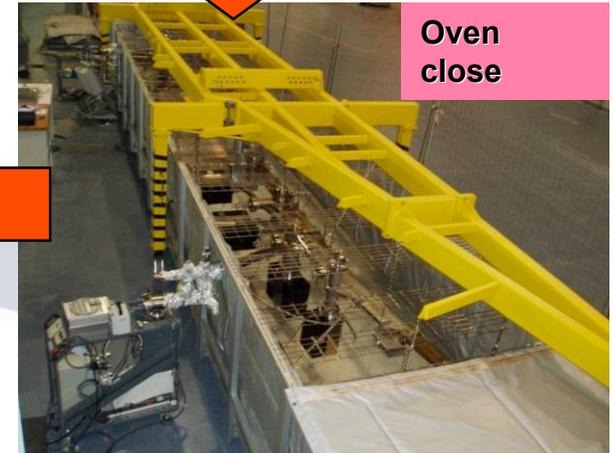
Oven close

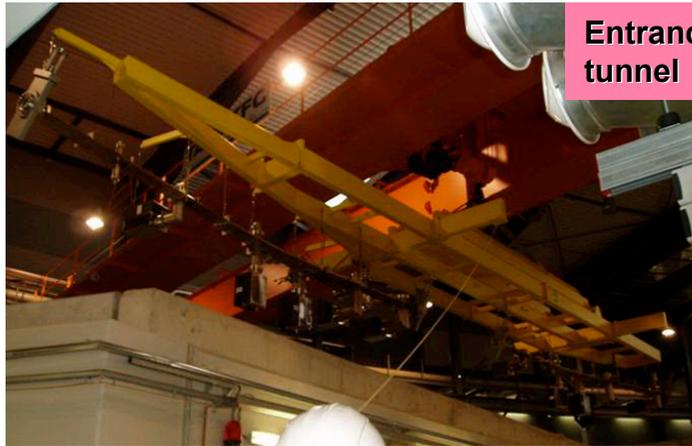
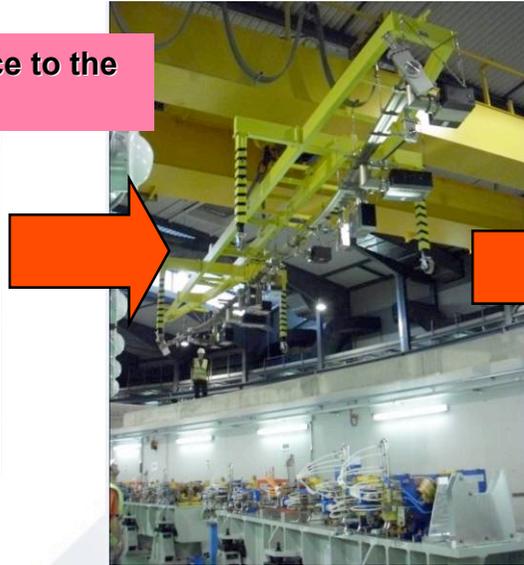
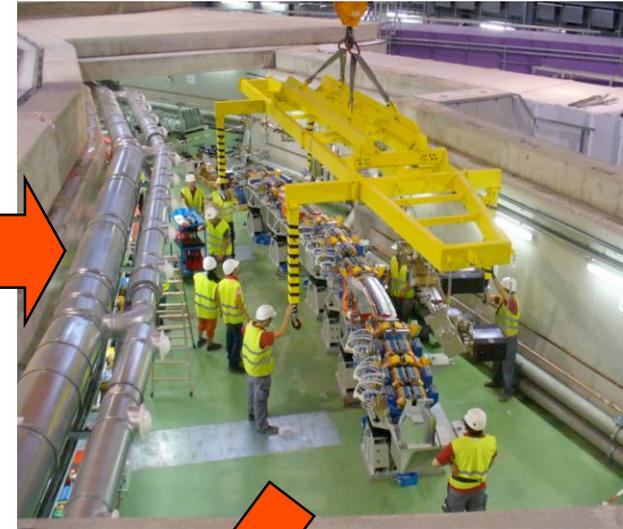
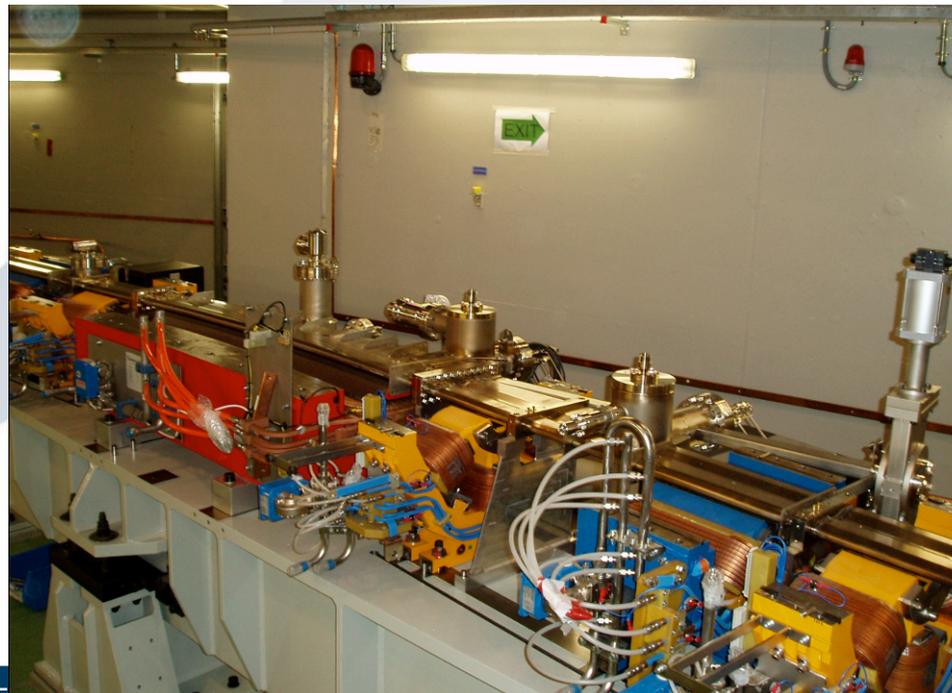
The sector is in place, ion pumps connected, RGA scan is done then magnets closed.

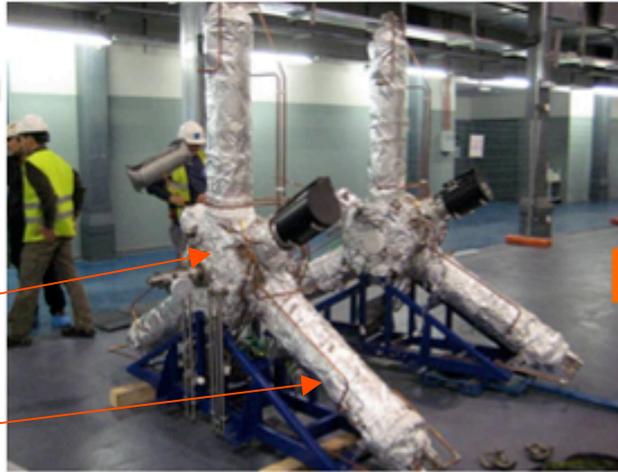
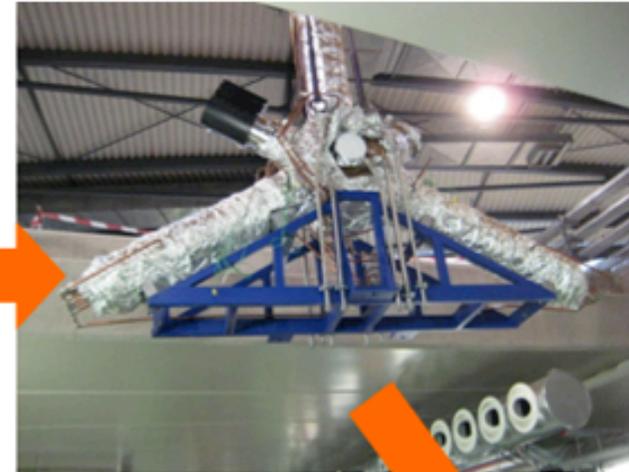
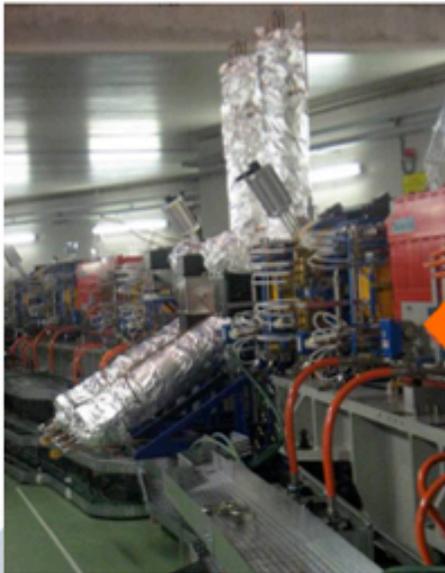
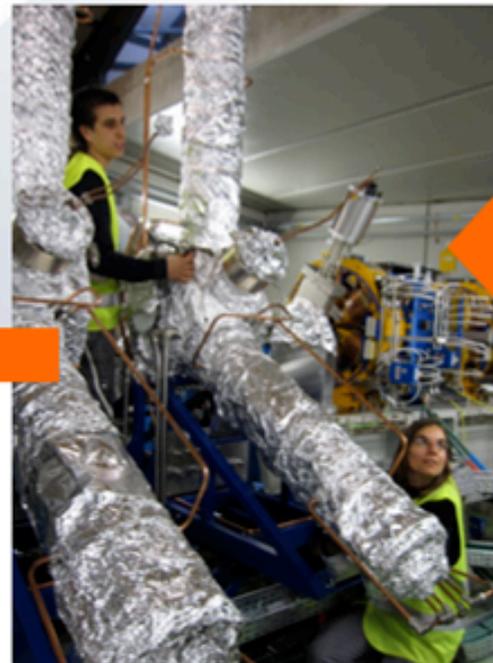
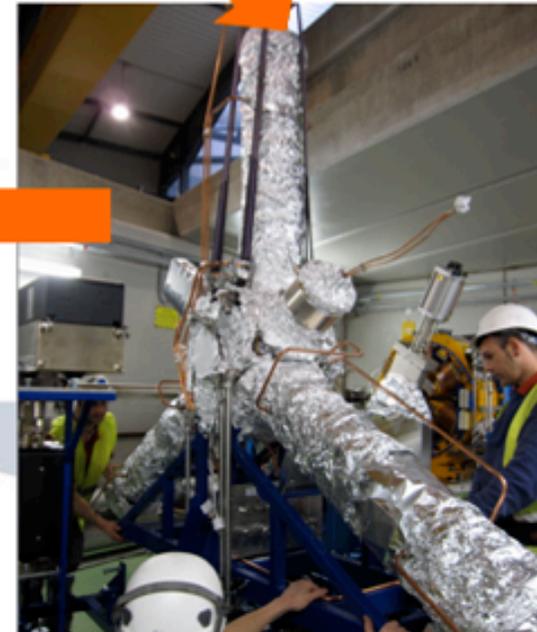
RF straight
installation

RF Cavity

HOM
dumper

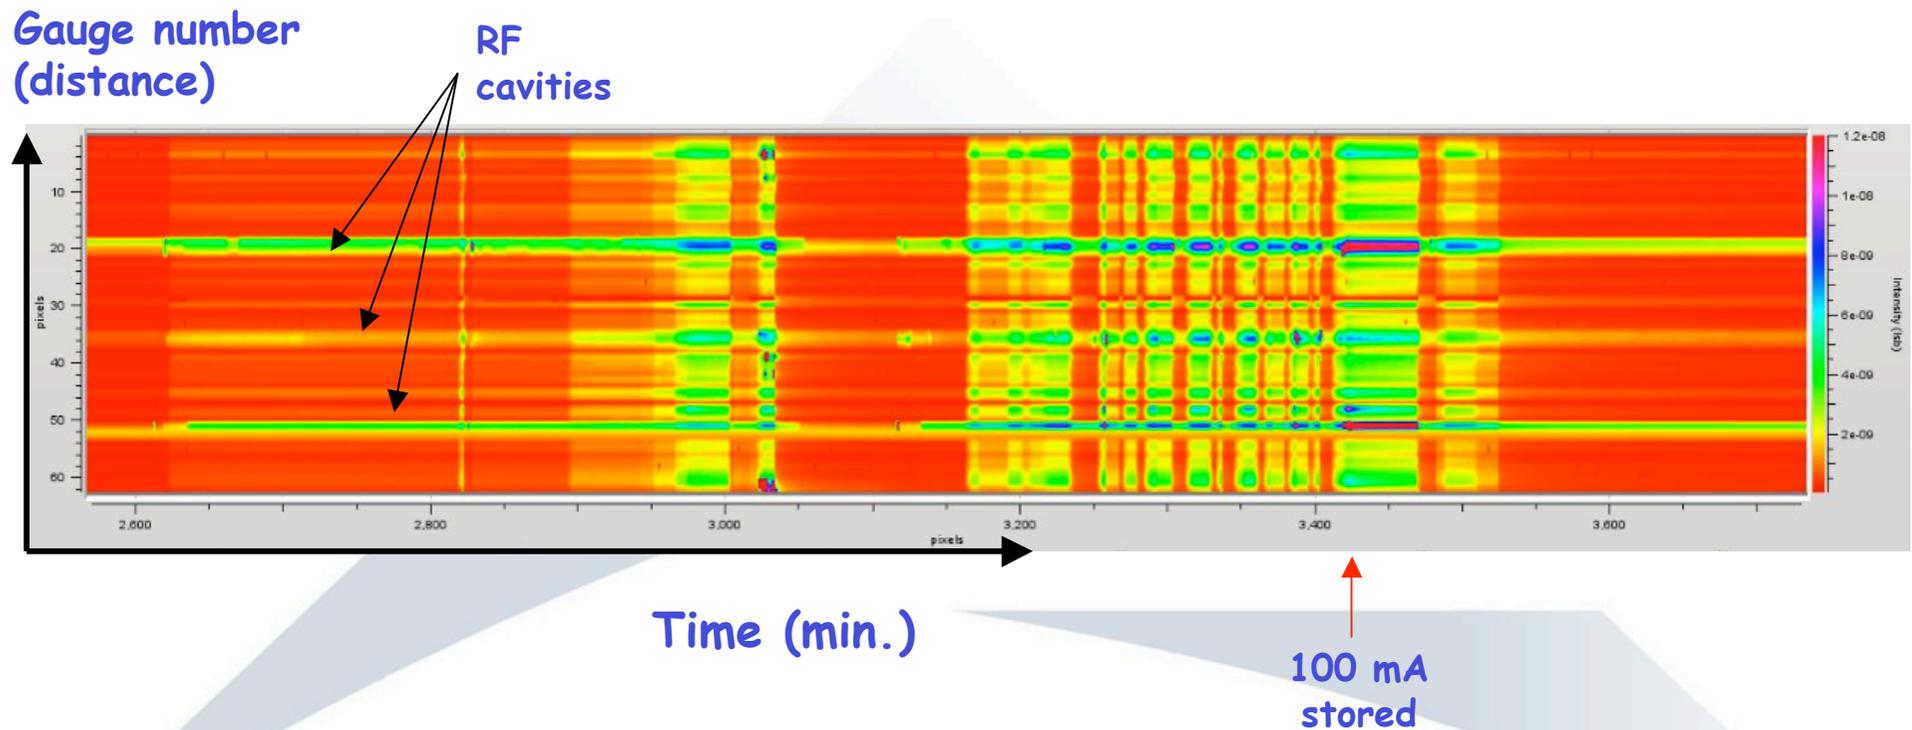
Pressure during one shift

6th June 2011 evening shift, vacuum gauge readings.

- Average pressure before injecting the first beam = $4 \cdot 10^{-10}$ mbar, thermal outgassing estimated = $1 \cdot 10^{-11}$ mbar.l/(s.cm²).
- With the first stored beam in the machine (beam current = 0.1 mA), the average pressure increased into $2 \cdot 10^{-8}$ mbar.
- With accumulated beam dose of 4.5 A.h, 80 mA stored beam current, the average pressure of the SR is $8 \cdot 10^{-10}$ mbar.

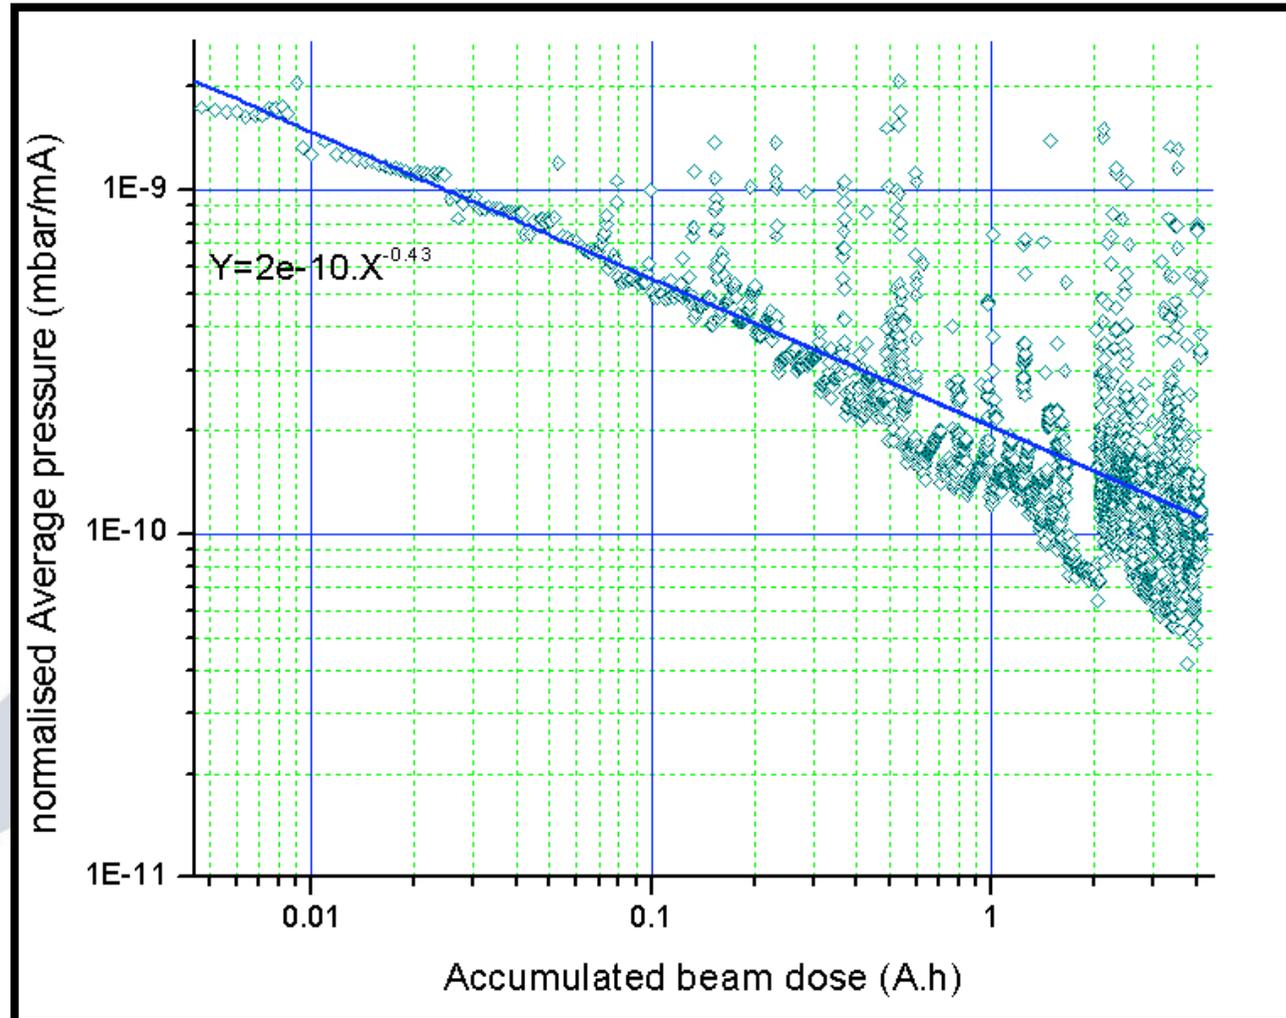
Normalized average pressure

The normalized average pressure of the SR to the beam current over the accumulated beam dose.

(measurements from CCG gauges)

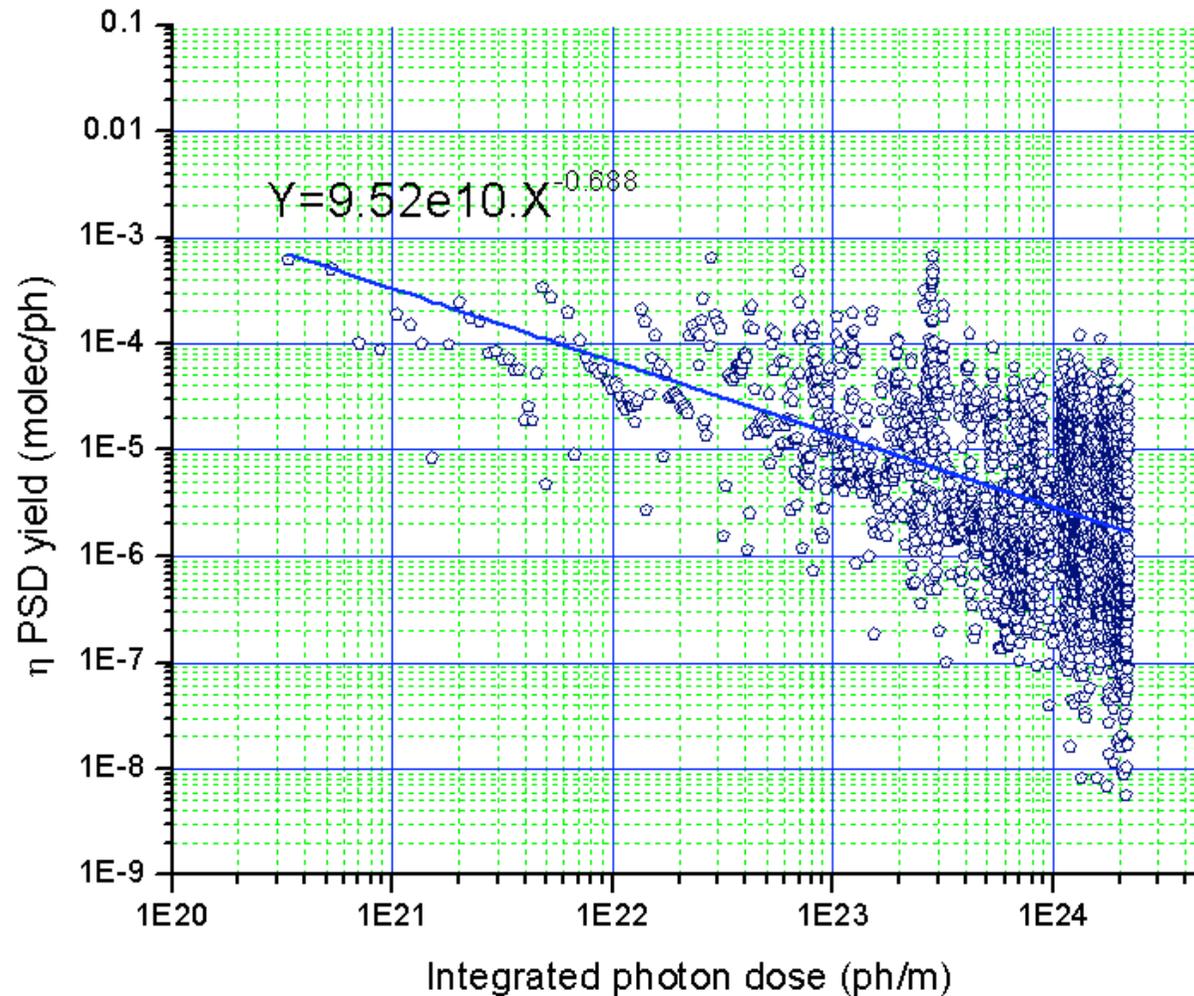
The estimated PSD yield (η) (molecules/photon) as a function of the integrated photon flux, the slope of the conditioning is 0.69.

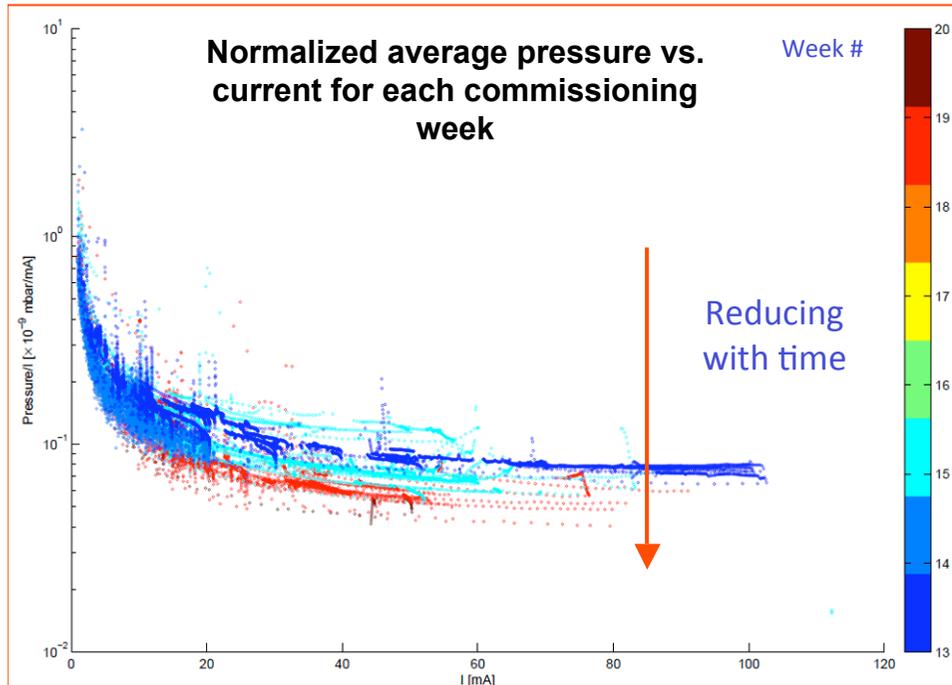
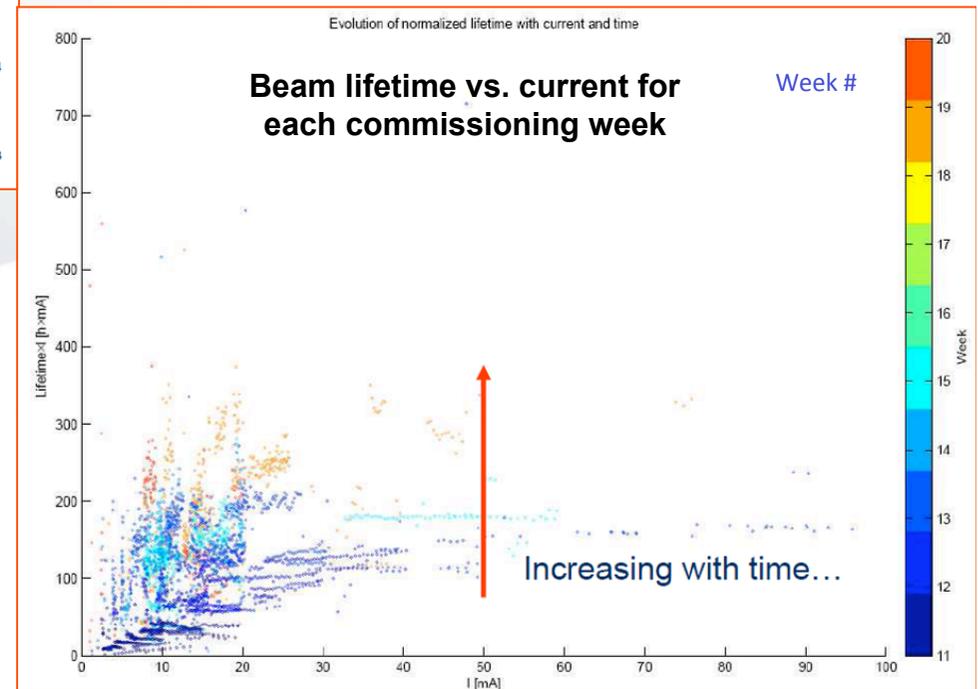
Pressure evolution and beamlife time.

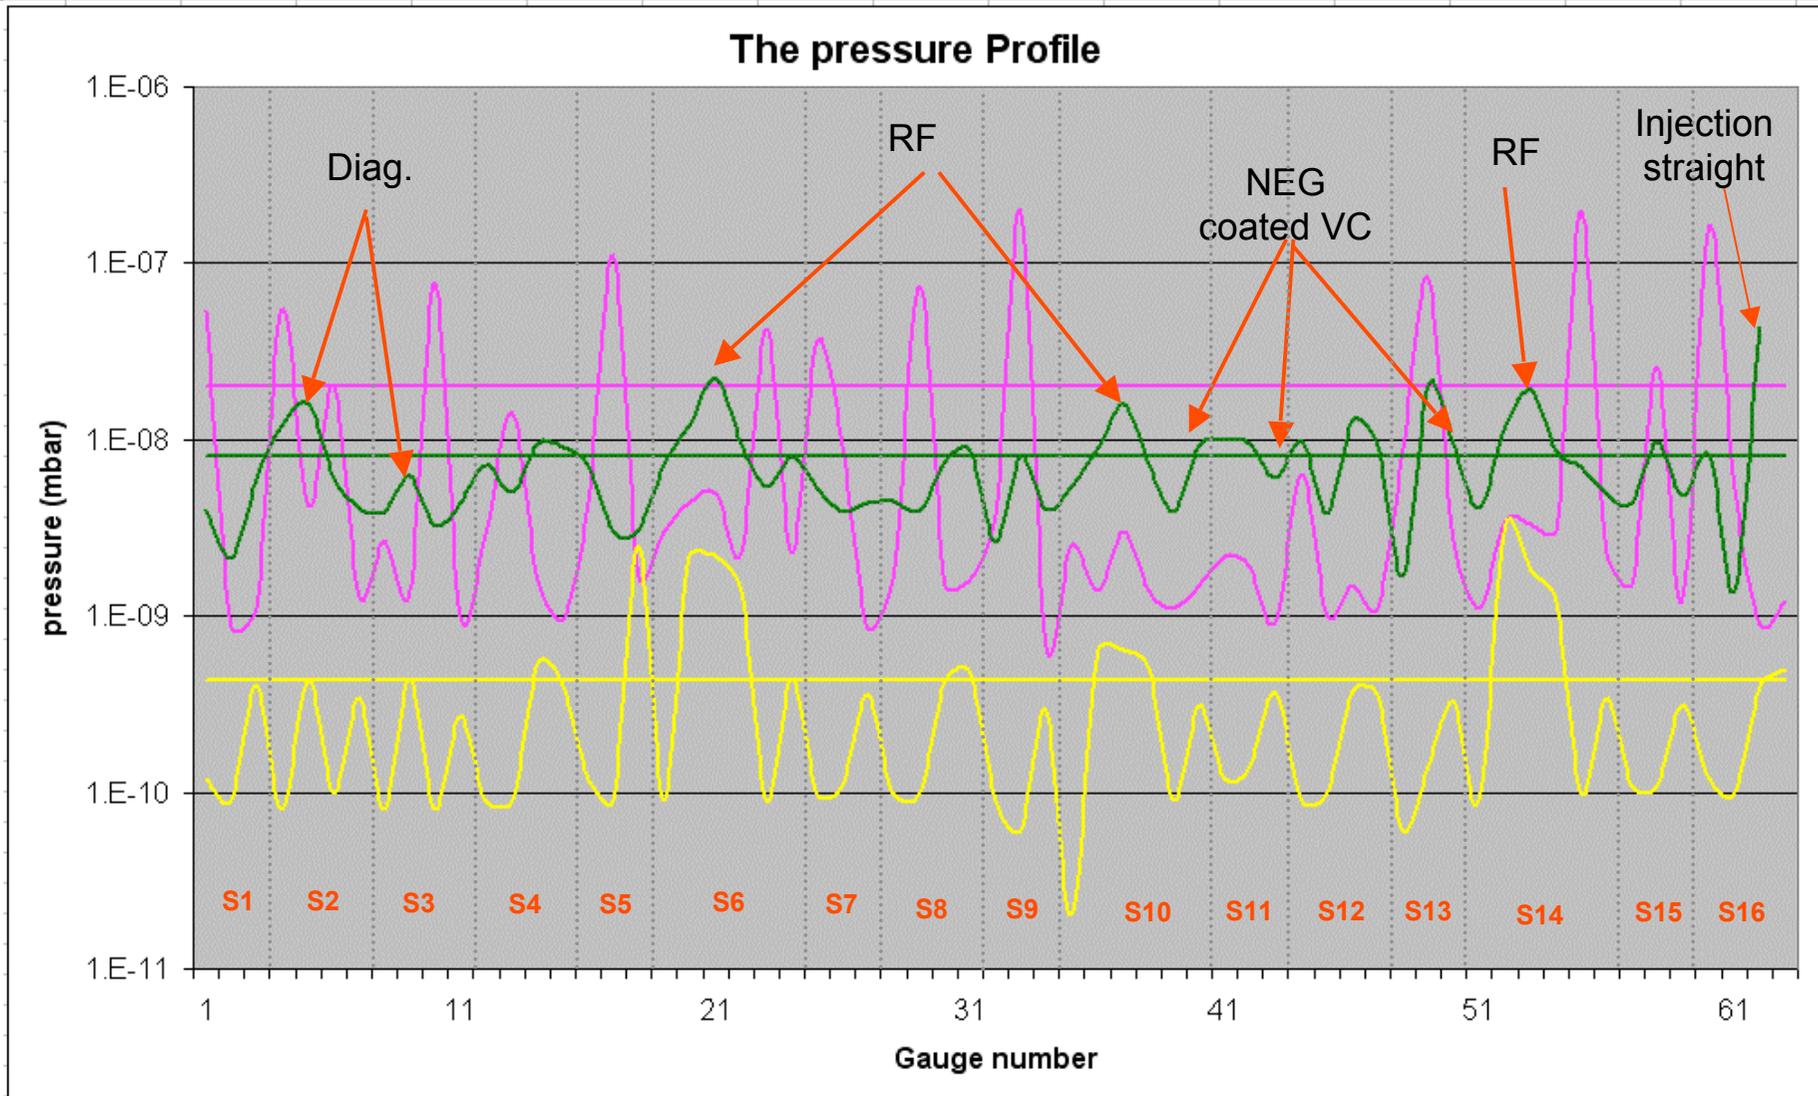
The pressure profile

Yellow= base pressure.

Cyan= First stored beam

Green= first stored 100 mA.

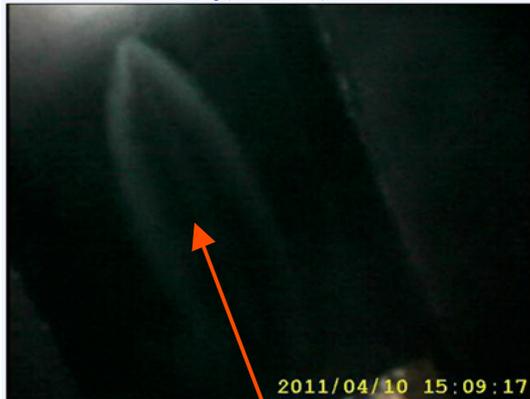
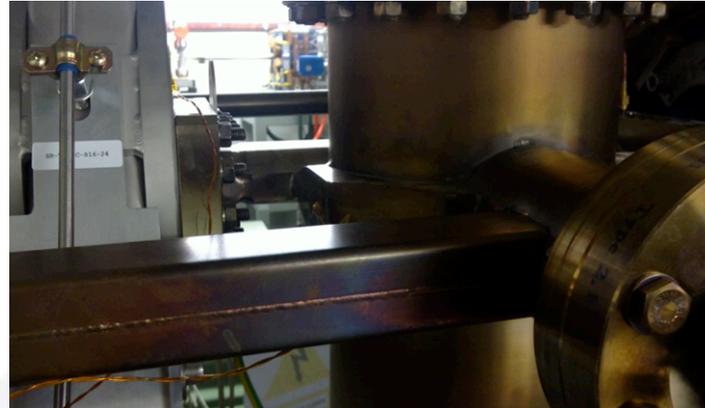
SR hit the vacuum chamber.

Inside the chamber

problem	diagnostic	solution
Pressure reading oscillation in the Pirani and the cold cathode gauges in the booster during magnets ramping.	Reading oscillation in the CCG and Pirani	No solution: we grounded all the gauges and there was a small change in the oscillation, for the CCG the oscillation is small, we live with it!
Failures in the power supplies of the ion pumps.	Error messages in the controller, and no power supplied to ion pump, increase in the pressure.	Solution is still under work with the supplier. Possible cause lose connectors.
Inlet and outlet water tubes are swapped (no flow of water in the absorber)	Thermocouple placed in the water return cooling tube of the absorber is showing high temperature.	Correct the water connection
SR hit the vacuum chamber	Thermocouple placed close to the area where the beam hit shows high readings.	Place a copper insert in the crotch absorber which shadows the vacuum chamber.

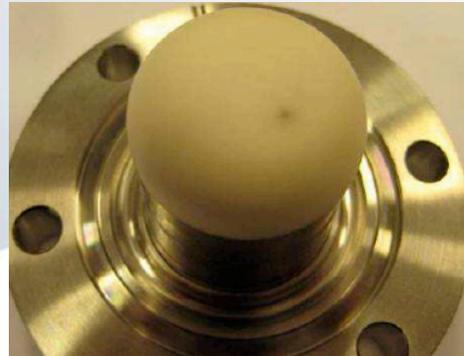
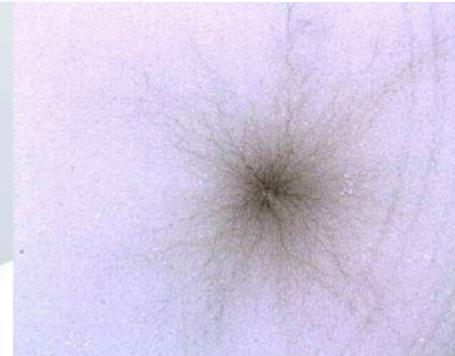
Leaks in pick up loops of the RF cavities.

Low water flow in the absorbers before the RF cavities	Thermocouples placed in the VC above the absorbers show high temp. water flow checked and it was half the required value.	Increase the water flow.
Leak in the pick up loop of the RF cavities due to sparks.	RGA scans show Ar. And the pressure in the cavities increased and has not recovered when the cavities are off.	Replace the leaky pick up loop
